MISCELLANEOUS PAPER SL-79-25

INVESTIGATION OF LIGHTWEIGHT CONCRETE AND MATERIALS, EAST LOS ANGELES COMPREHENSIVE HEALTH CENTER BUILDING

A. D. Buck and T. C. Liu

November 1979

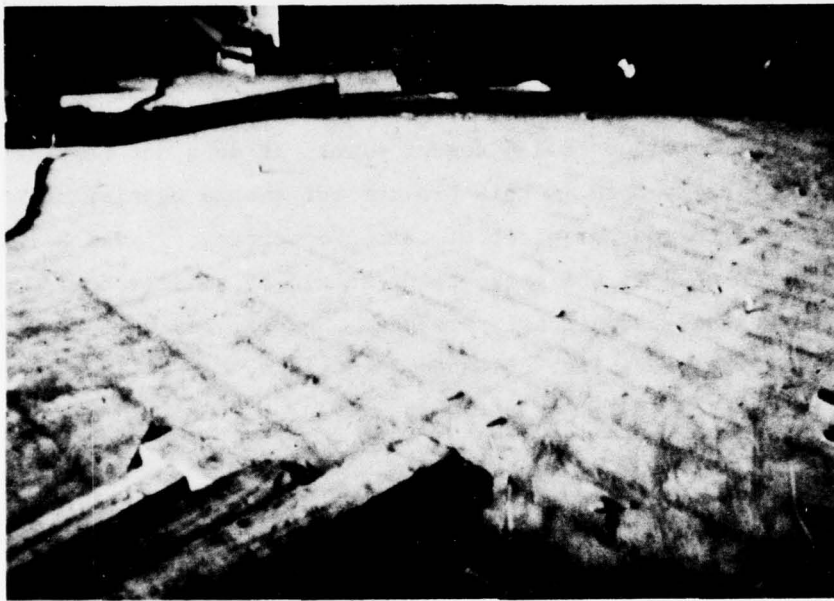
1. It was observed during construction of the building that an unusual effect developed on the upper surfaces of four of the floors. The effect was that of a square grid pattern with the sides of the squares being 1/4 to 1/2 in. lower than the rest of the squares (Figure 1). Since each square was about 8 in.* on a side, it was apparent that the pattern was outlining the upper layer of reinforcing steel bars which were intended to be 3/4 in. below the surface of the concrete. Visually this surface looked like a waffle with the ribs being low instead of high.

Figure 1. Typical grid pattern in the hardened lightweight concrete floor slabs.

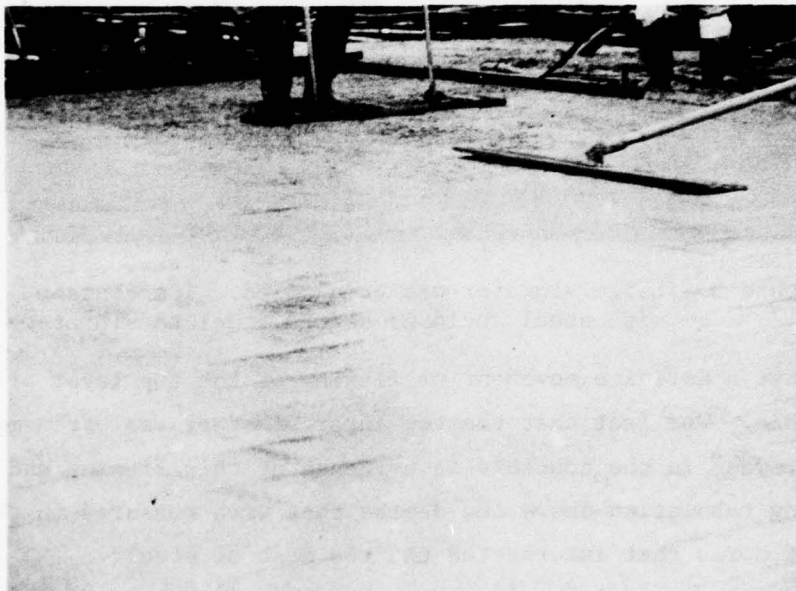
21. Study of the jobsite photographs showed that the waffle effect was clearly visible soon after the initial bull floating operation and long before the final finishing was done (Figure 2). This meant the effect was occurring somewhere between 30 minutes to 75 minutes after the concrete was batched. The short elapsed time between smoothing of the freshly placed concrete and appearance of the waffle effect made it unlikely that pronounced effects of gas generation from aluminum contamination would be seen so soon.

Figure 2. Waffle effect was visible on concrete surface almost immediately after placement.

22. The photographs show that the early waffle effect or a large part of it was probably due to flexing of the top layer of steel during placement and strike-off activities adjacent to freshly smoothed areas.

37. The way to avoid a repetition of this problem would probably involve several steps. These would include lowering the level of the steel mat, increasing the rigidity of the upper steel mat to eliminate or reduce its ability to sag or flex, reducing the slump of the concrete, and immediate finishing (smoothing) of concrete surfaces to remove any grid pattern that might develop. The elimination of aluminum contamination might also be desirable.

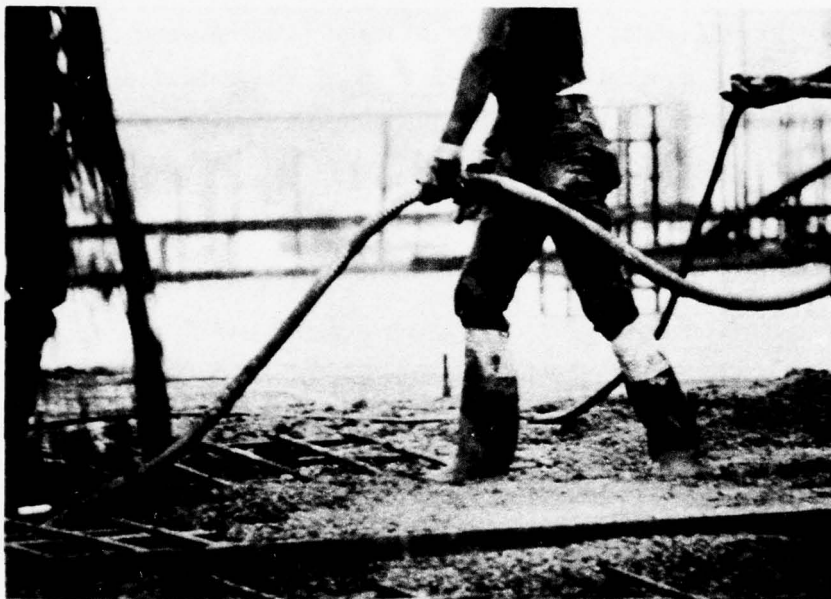
One slide shows individual bars sagging beneath each foot of a worker. Another slide shows that it was almost a certainty that the vibrator being used would hit some of the top steel, causing it to transmit vibrations along its length (Figure 3). The sequence of photographs

Figure 3. Large vibrator was being used. Its contact with steel would cause the steel to vibrate.

indicates that a definite movement or flexing of the top layer of steel was inevitable. The fact that the top layer of steel was often more than 3/4 in. deep in the concrete is evidence of this flexing and sagging. The following tabulation shows the depths that were measured in the five of the eight cores that intersected the top mesh of steel:

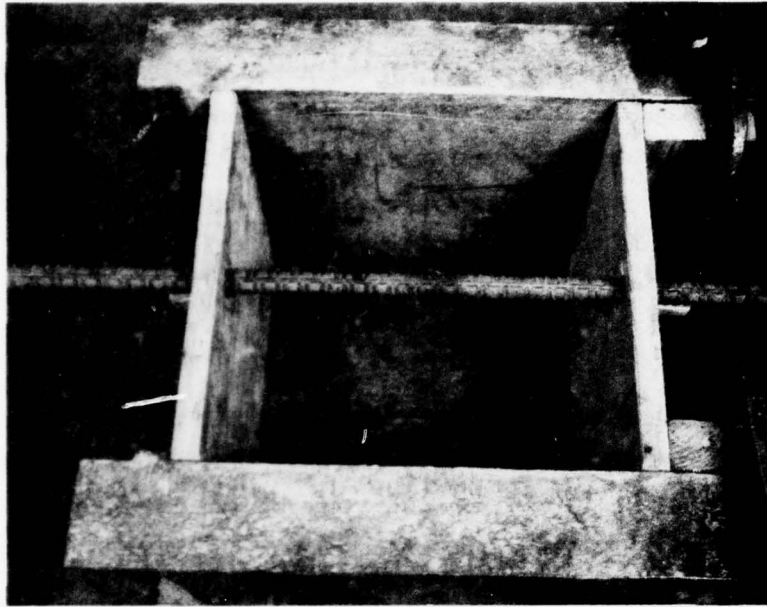
Figure 4. Location of reinforcing steel in the form.

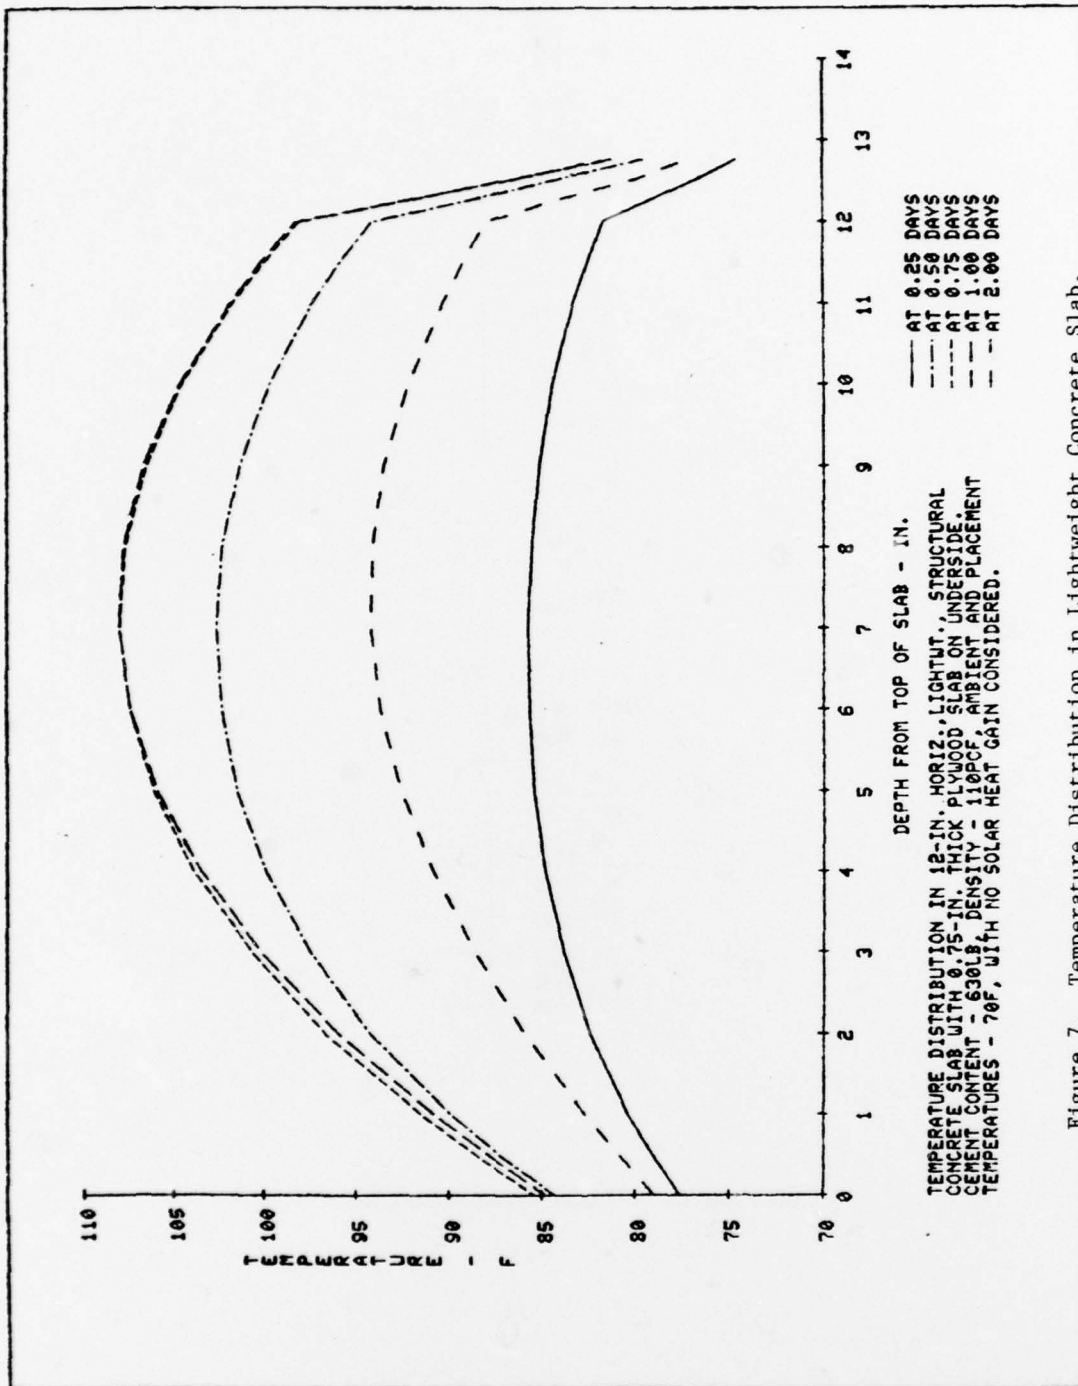
31. The calculated temperature distribution in the lightweight concrete slab is shown in Figure 7. It can be seen that peak temperatures of approximately 108°F were attained at about 19 hours after placement. The temperature history at 7 in. from the top surface (position at which peak temperature is reached) is shown in Figure 8. This temperature information was transmitted to Osborne Laboratories, Inc. through County of Los Angeles Facilities Department on 13 September 1978.

Figure 7. Temperature Distribution in Lightweight Concrete Slab.

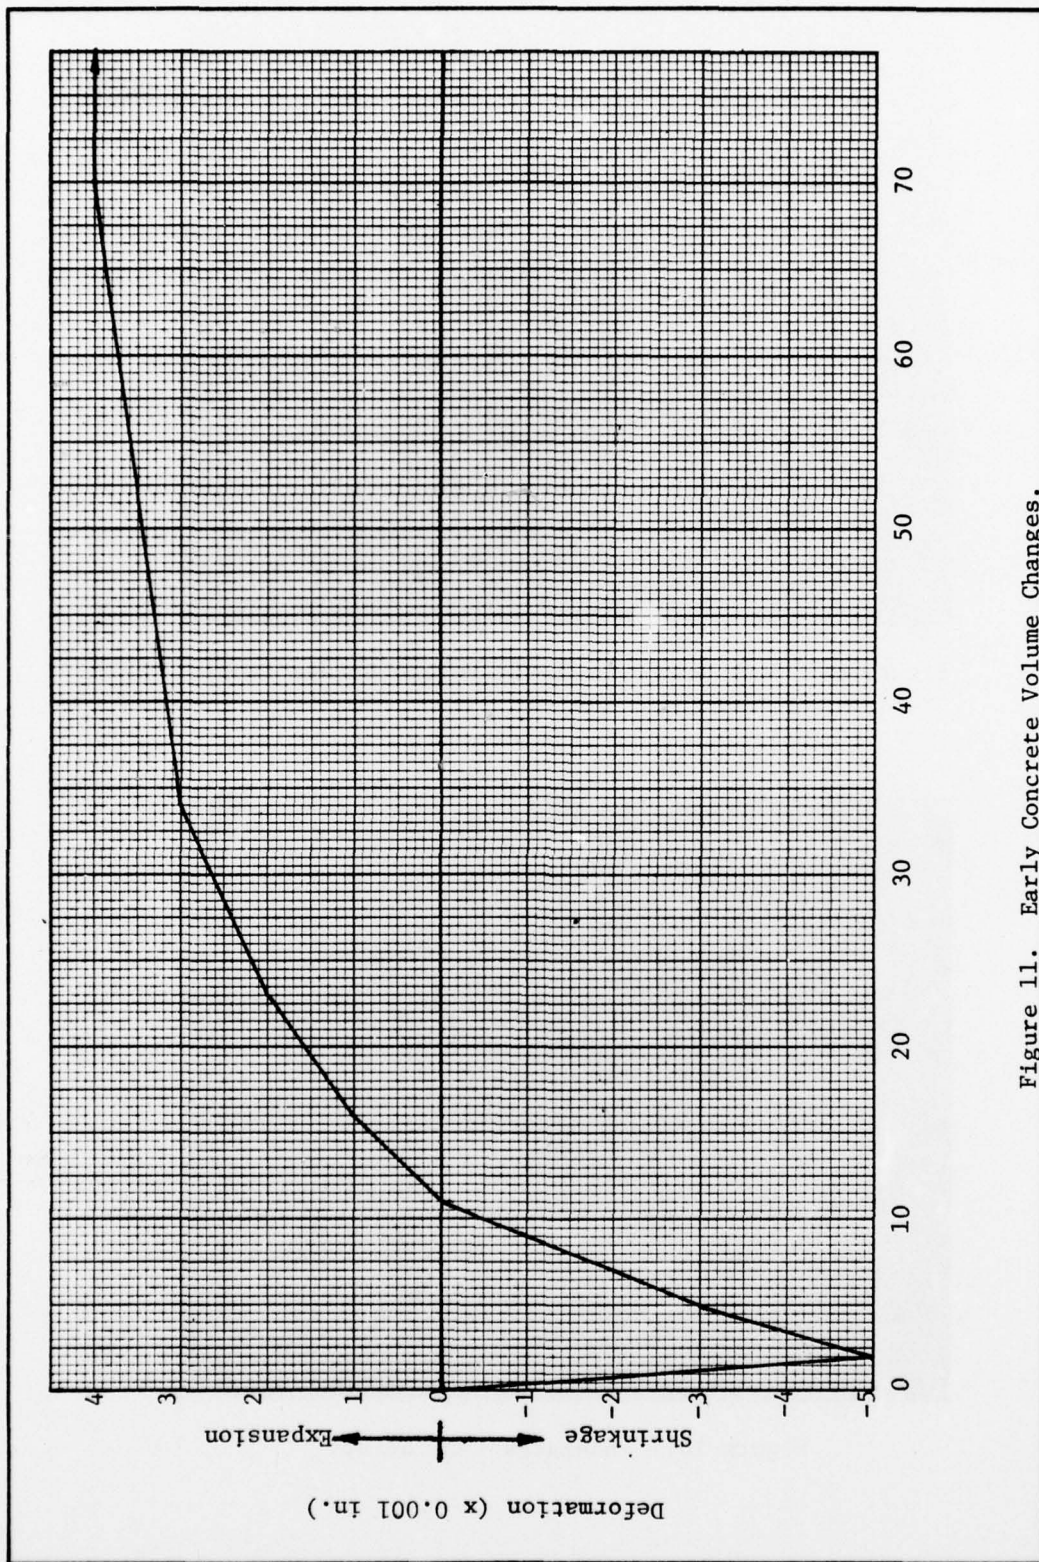
34. The test results are shown in Figure 11. It can be seen that during the first two hours, the concrete underwent a contraction (total vertical subsidence) whose magnitude was of the order of 0.005 in. Following this initial contraction, the concrete expanded due to temperature rise in the concrete. The magnitude of expansion was about 0.009 in. or a net of 0.004 in. based on the initial volume at 70 hours after casting and remained essentially constant thereafter. This recorded

Figure 11. Early Concrete Volume Changes.

expansion is approximately one one-hundredth of the relative difference in elevation of the high and low places as observed in the waffle pattern in the structure where it is most fully developed.

35. Based on the results of this test, it may be concluded that early volume growth of the lightweight concrete was not the main contributing factor for the undulation problem.
